# SINUS AUGMENTATION: BILATERAL, FIRST MOLAR AREA | 36 MONTHS FOLLOW-UP

## CLINICAL CASE

**Lee, Myung Ho, D.D.S.**

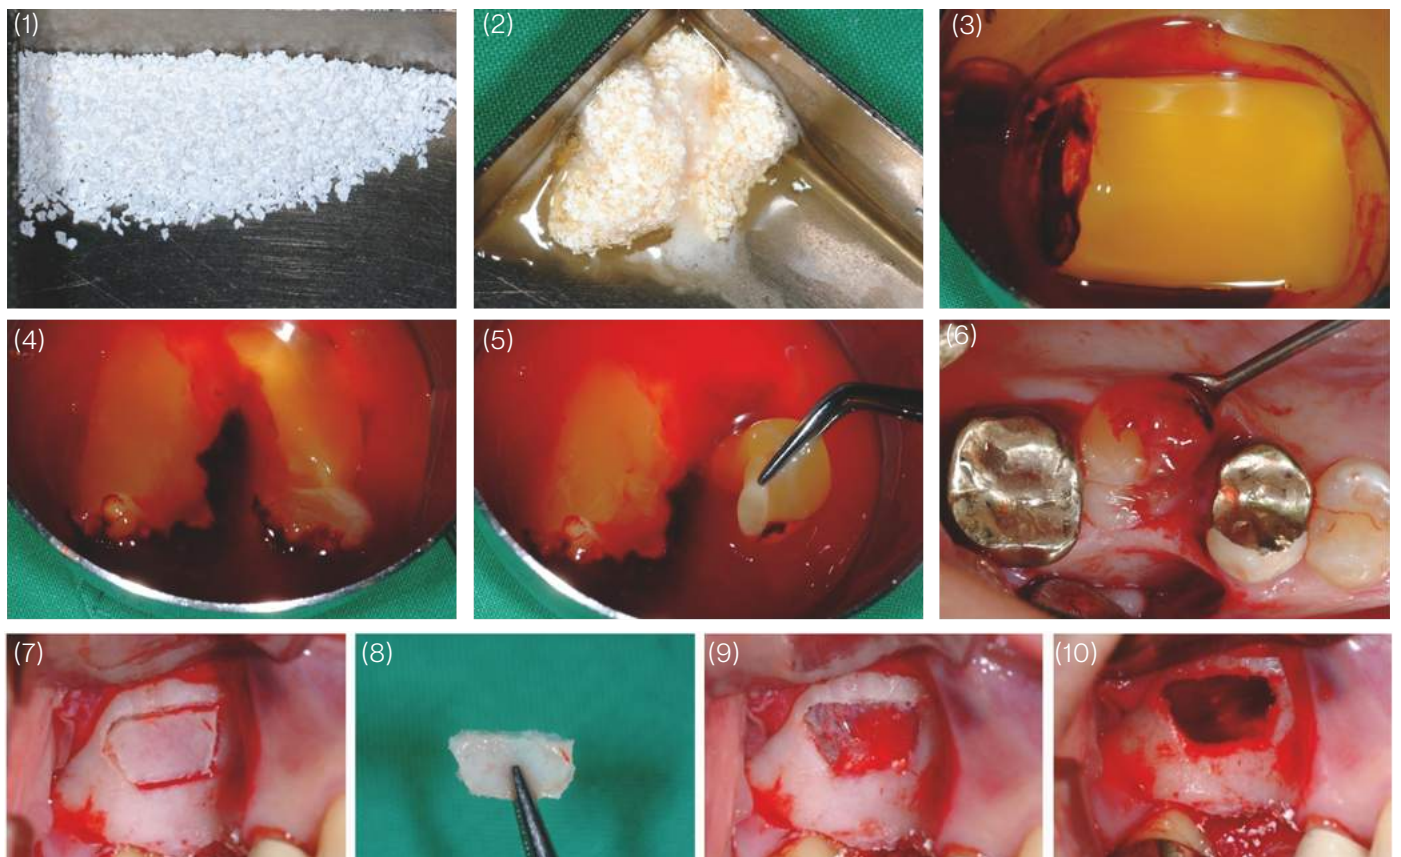
**Figure 4. (1-2)** A mixture of advanced bone graft solution from Chiyewon and PRP was used, and PRF (3-4-5-6) was placed beneath the sinus membrane. (7-8-9-10) A window was created for access .

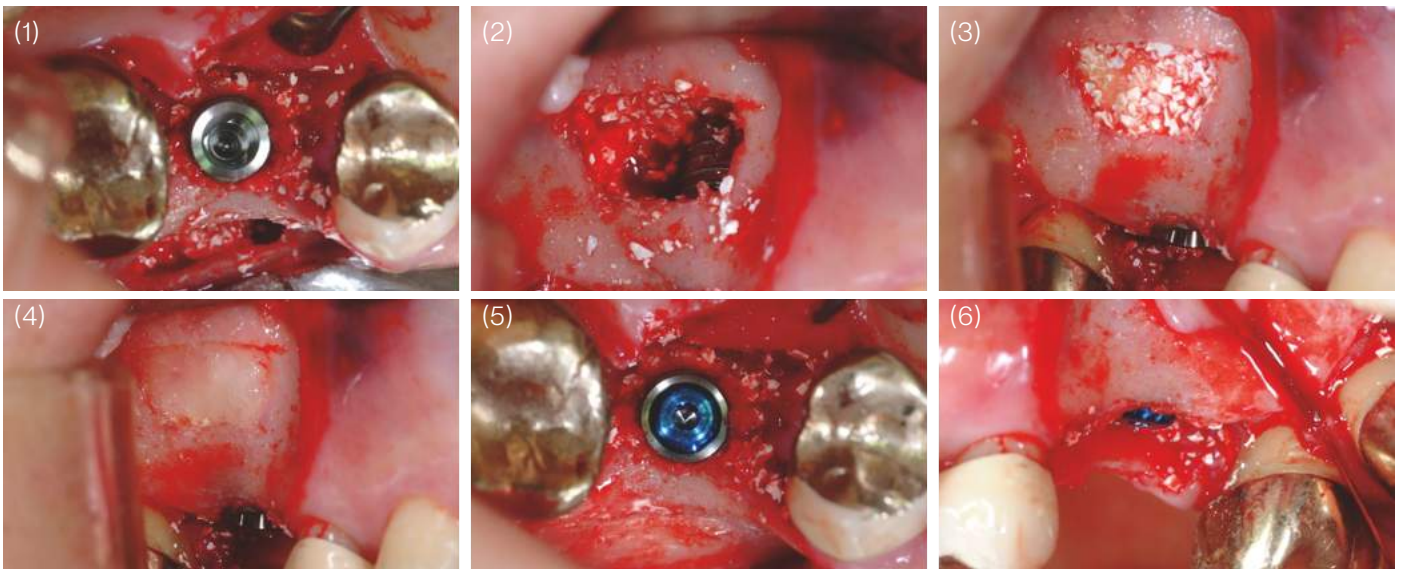
**Figure 5.** The advanced bone graft solution from Chiyewon was placed inside the sinus window **(2-3)**, and the window plate was repositioned to cover the graft **(4)**.

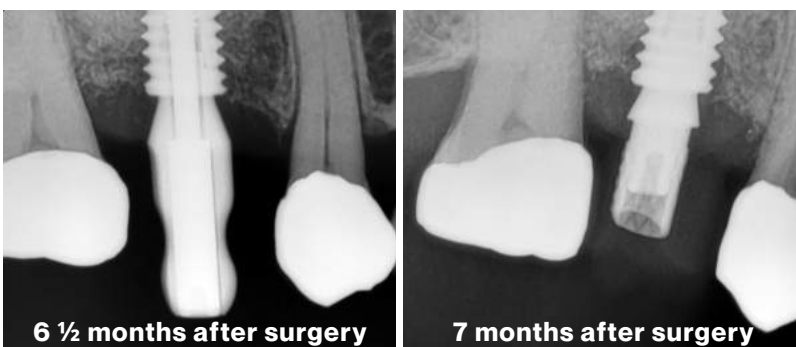
**Figure 8. 6 months ½ and 7 months after surgery:** The bone graft material is sufficiently matured to effectively resist occlusal forces.

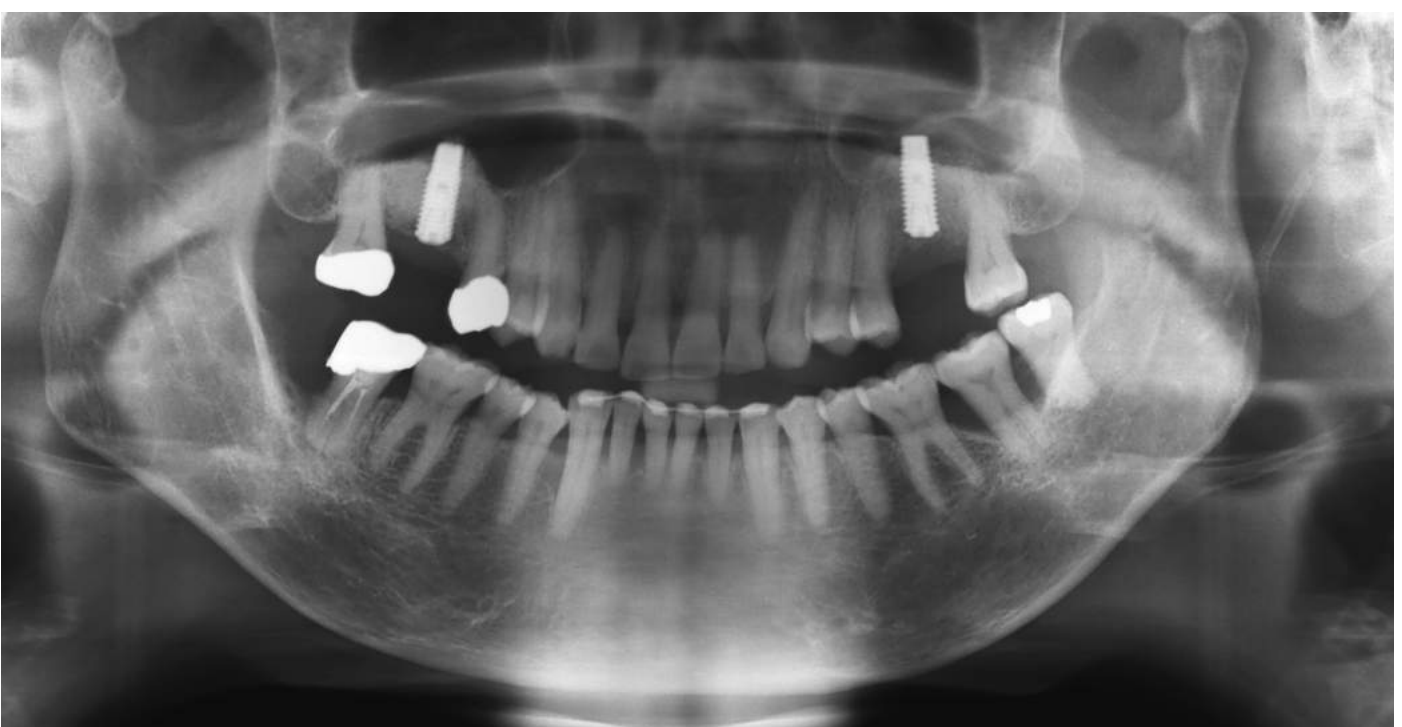
**Figure 12.** The radiograph shows a postoperative panoramic view of the tooth #26 area following the surgical intervention.

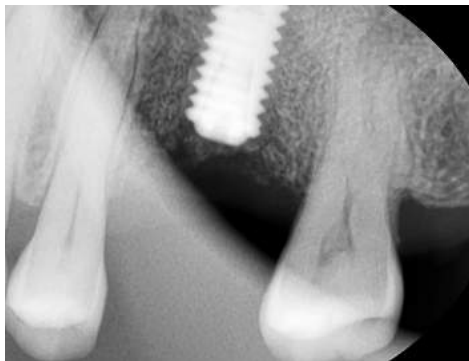
**Figure 15. 3 Months after Surgery:** The advanced bone graft solution from Chiyewon has begun to exhibit a densified image in both the sinus area and the coronal part of the implant, indicating successful osseointegration and bone density increase.

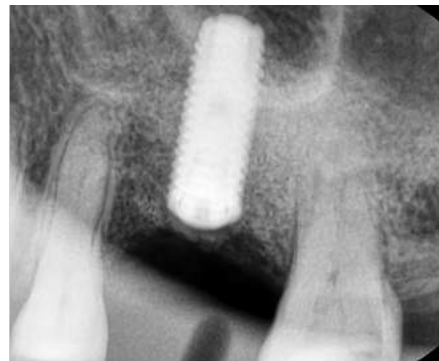
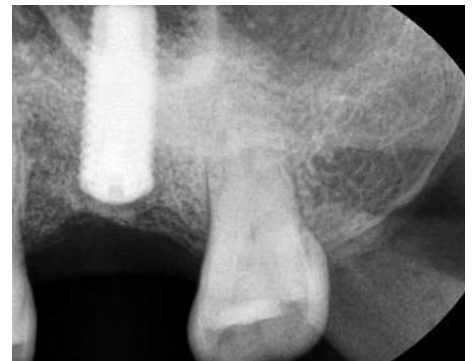
**Figure 16. 5 Months after Surgery:** A well-matured image of the the bone graft has been observed in the sinus area and the coronal part of the implant.

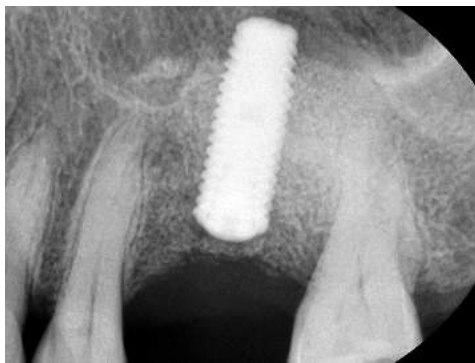
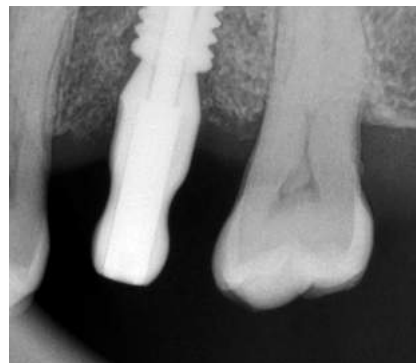
**Figure 17. 6 Months after Surgery:** The bone graft has shown its maturity and is now deemed unrecognizable in imaging analyses. This indicates that the graft has effectively integrated with the surrounding bone.

Radiopaque and periapical radiographic images show that after 6 months, the graft had effectively integrated with the surrounding bone. Bone levels remained **consistent over 24 months** and **up to 36 months after surgery**, confirming **long-term regenerative success**.
