HORIZONTAL & VERTICAL AUGMENTATION: MAXILLARY RIGHT, FIRST MOLAR 47 MONTHS FOLLOW-UP

CLINICAL CASE

Lee, Myung Ho, D.D.S.

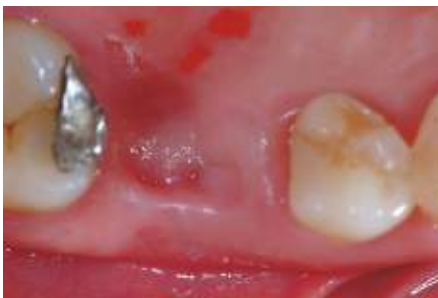
Figure 2. Intraoral soft tissue images shows relatively within normal range.

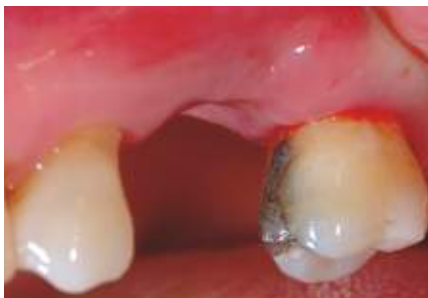
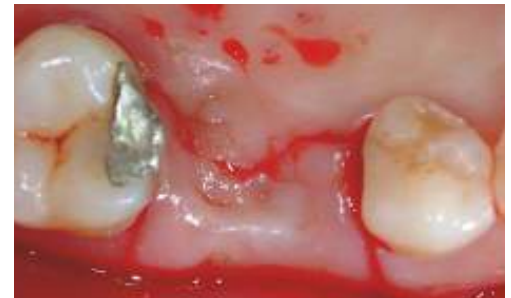
Figure 3. Linear and vertical incisions were performed in the region of teeth #15 and #17 to access the surgical site.

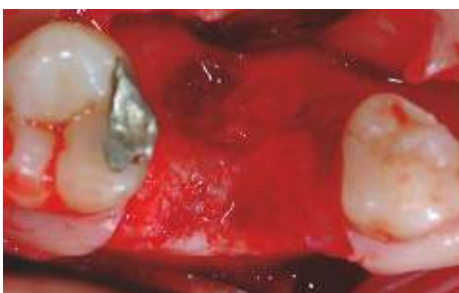
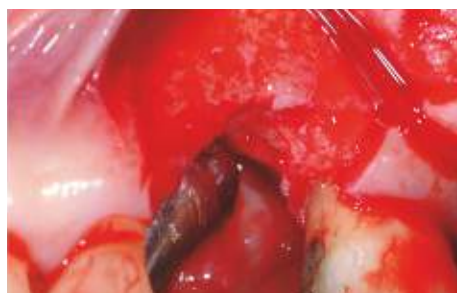
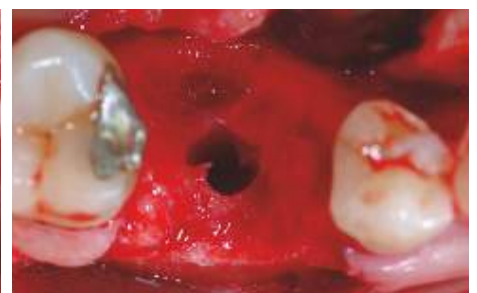
Figure 4. Flap elevation was performed. Buccal and palatal walls all destroyed. In order to match the level of adjacent teeth, vertical and horizontal buildup was required.

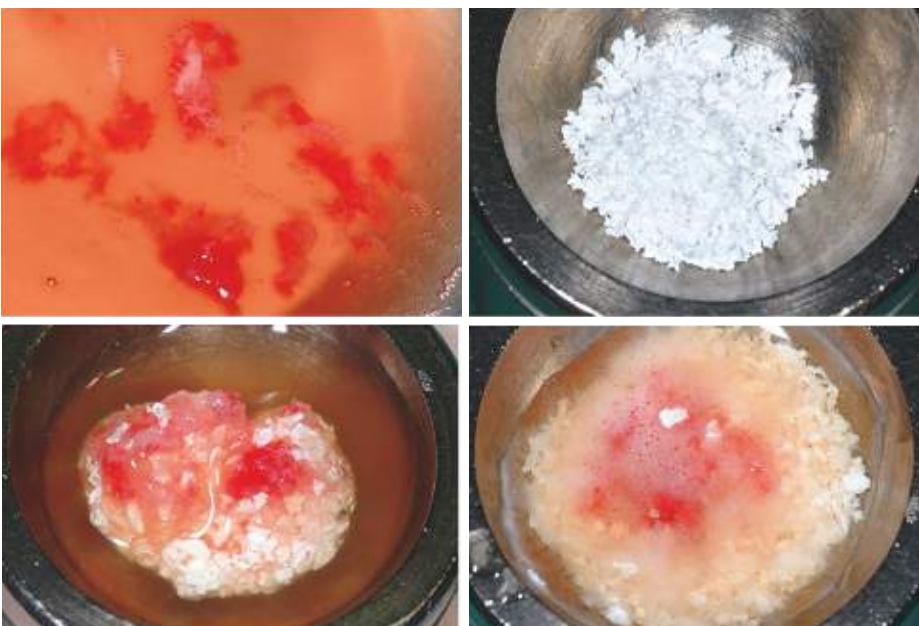
Figure 7. A mixture of advanced bone graft from Chiyewon and PRP was used.

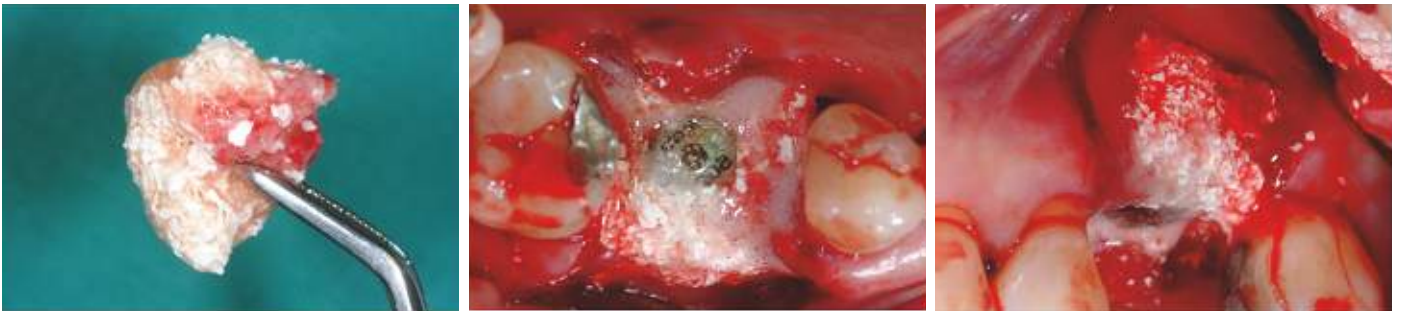
Figure 8. The advanced bone graft from Chiyewon & PRP mass picked up and shaped around the implant to fill up the defect.

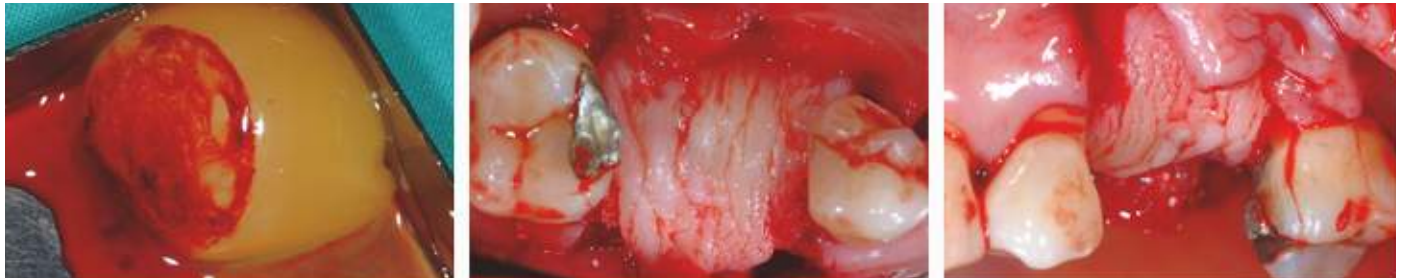
Figure 9. PRF was placed over and used to cover the bone graft.

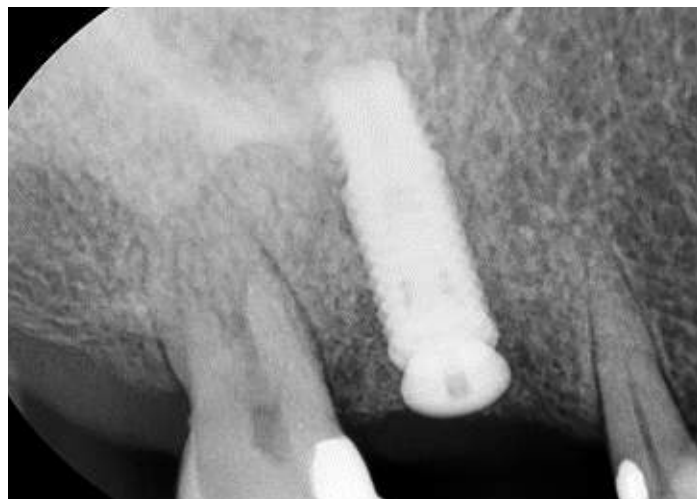
Figure 14. 1 month after surgery: The periapical image of Chiyewon's bone graft began to exhibit an opaquesness.

Radiographic and CBCT evaluations at 8 months post-surgery confirmed successful vertical and horizontal bone regeneration despite the complete destruction of both buccal and palatal walls (Figure 17). The graft material (Chiyewon advanced bone graft with PRP/PRF) showed progressive integration from 1 month post-surgery (Figure 14), with stable bone levels maintained up to 47 months after surgery (Figure 19).

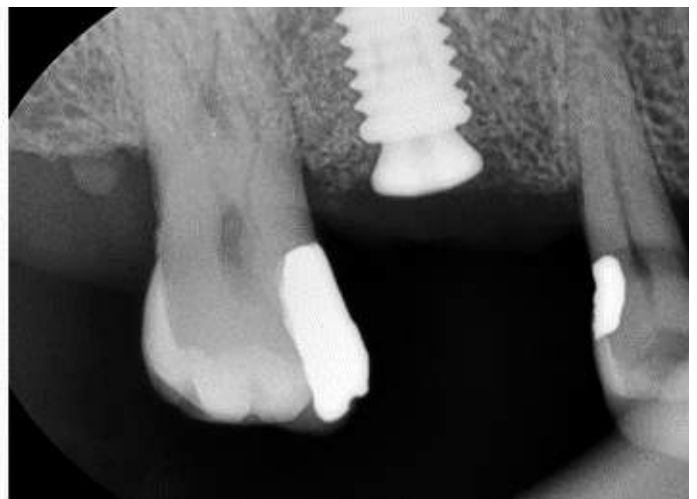
Figure 15. 2 months after surgery: The periapical image shows well settled and organized appearance of the Chiyewon's bone graft mass.
